U.S. Department
of Transportation
**Federal Highway
Administration**

Name of system: MASH Sequentially Kinking Terminal (MSKT) Powder Coated

Figure 1. Photographs of Bogie Test Installation

Subject: Powder Coated Rail and Impact Heads for FLEAT and SKT W-Beam
Terminals

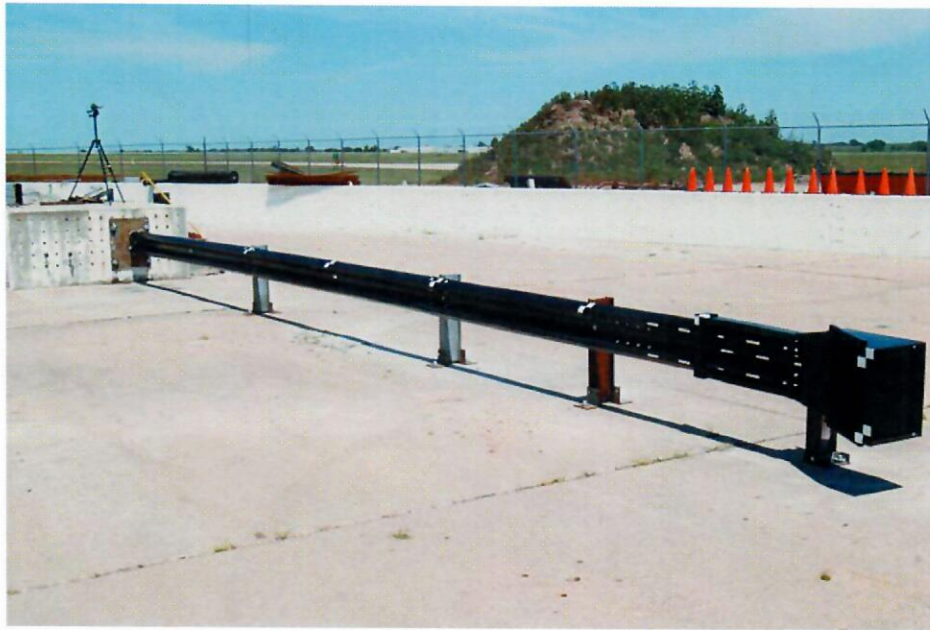
Bogie Test. A bogie test of the powder coated rail was conducted at the Midwest Roadside Safety Facility (MwRSF). The test setup was similar to previous bogie tests conducted with standard galvanized rail. The test installation consisted of 11.43 m (37 ft 6 in.) of straight guardrail installation, as shown in Figure 1. The first 3.81-m (12 ft-6 in.) rail section was a special end rail for the FLEAT terminal with a FLEAT impact head installed at the upstream end. Posts 1 and 2 were terminal end posts spaced at 1.91 m (6 ft 3 in.). Note that the test installation did not have a cable anchor. Posts 3 and 4 were breakaway line posts, spaced at 1.91 m (6 ft 3 in.) and 3.81 m (12 ft 6 in.), respectively. The downstream end of the rail was bolted to an immovable block of concrete.

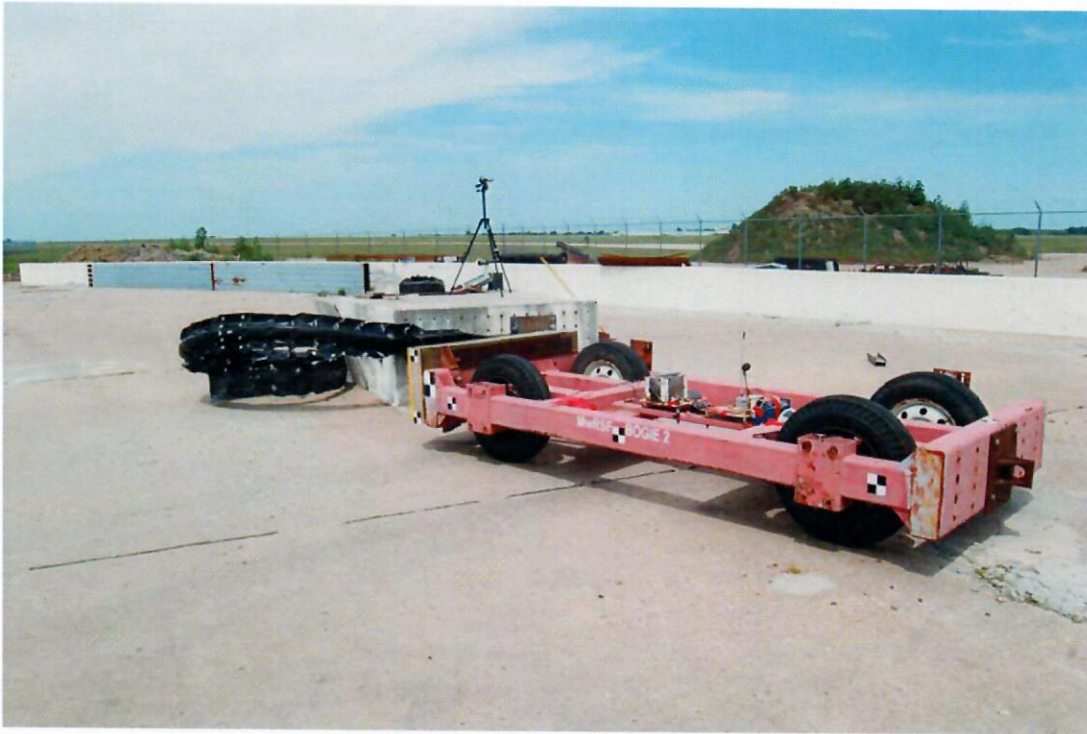
Figure 2. Photographs of Bogie Test Installation After Test

breaking the end post. The rail began to kink as designed. As the vehicle proceeded forward, the kinking continued and the posts broke away upon impact by the impact head. The entire length of 11.43 m (37 ft 6 in.) of rail was kinked and the bogie vehicle came to rest against the concrete block, as shown in Figure 2. A photograph of the kinked rail is shown in Figure 3. Detailed data and a video of the test are also available upon request.

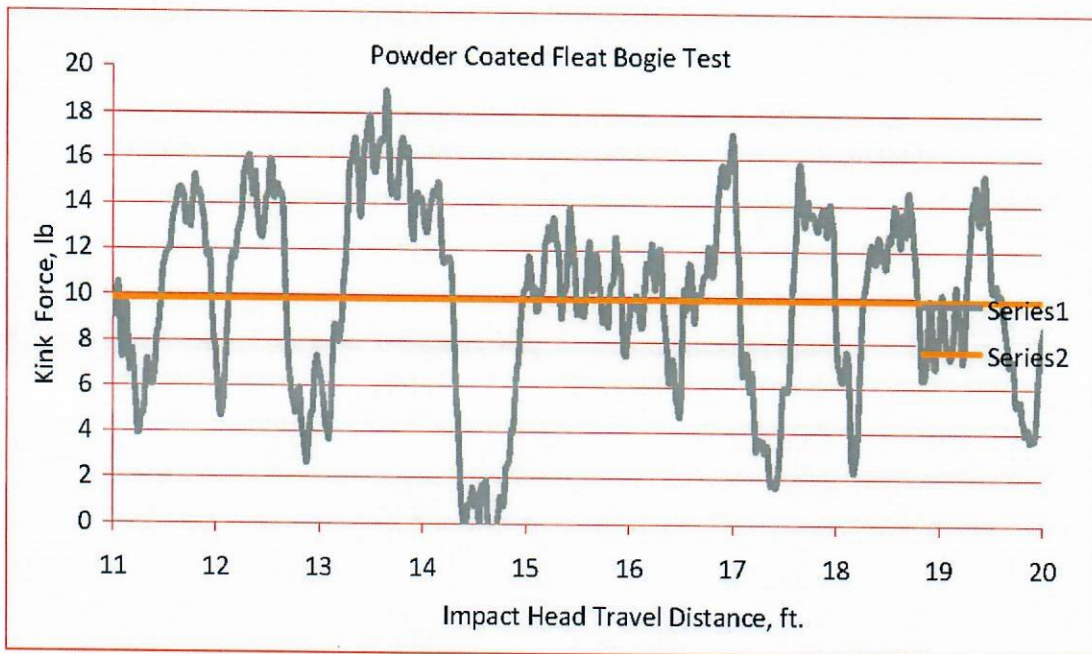
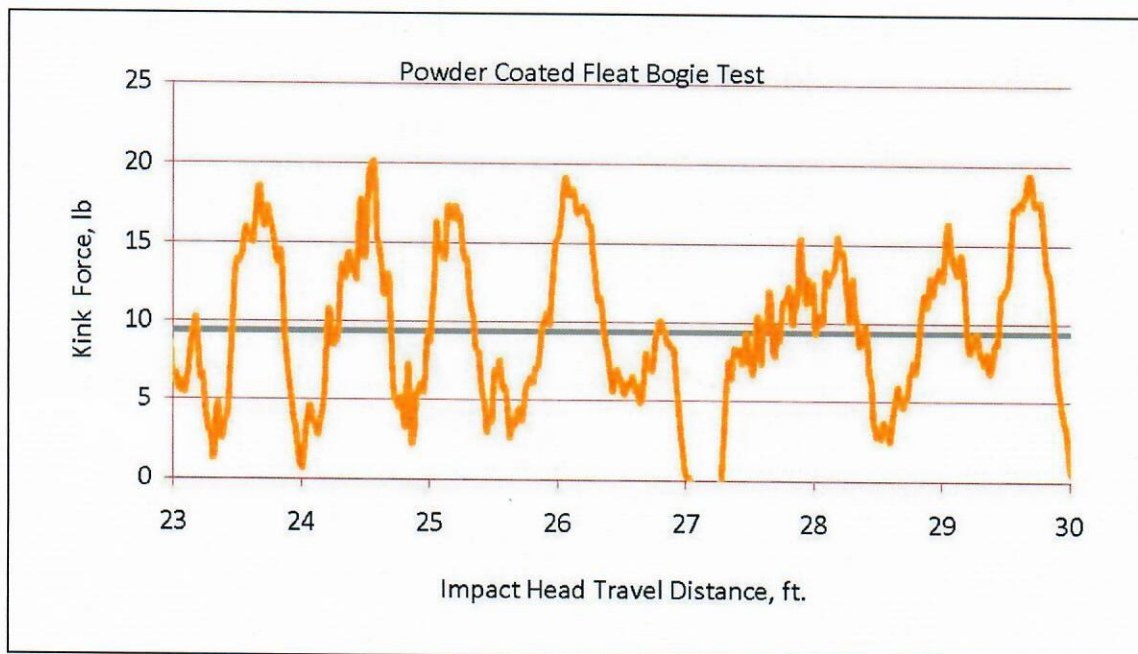
Figure 4. Plot of Kink Force v. Impact Head Travel Distance
Powder Coated FLEAT Bogie Test

Data Analysis. Figure 4 shows two partial plots of the kinking force over the impact head travel distance, one for 3.4 to 6.1 m (11 to 20 ft) and the second for 7 to 9.1 m (23 to 30 ft). As may be expected, the kinking force varies depending on the locations of the kinks and the breakaway posts. The kinking force averages 4,500 kg (9.9 kips) over the distance 3.4 to 6.1 m (11 to 20 ft) and 4,270 kg (9.4 kips) over the distance of 7 to 9.1 m (23 to 30 ft). In comparison, the average kinking force for a similar bogie test on a galvanized rail is 4,140 kg (9.1 kips), as shown in Figure 5.

Conclusions. The kinking force for the galvanized rail with a powder coated surface is similar, actually slightly higher, than that of a standard galvanized rail. Given the similarity in kinking force, it is logical to conclude that the impact performance of the powder coated rail would be similar to that of the standard galvanized rail. Thus, it is believed that the powder coated rail and impact heads can be used in place of the standard galvanized rail with no modification to the SKT or FLEAT terminal designs.
